## EMERGENCY REPAIR OF DRIVE PULLEY ON SITE (VERTICAL APPLICATION).

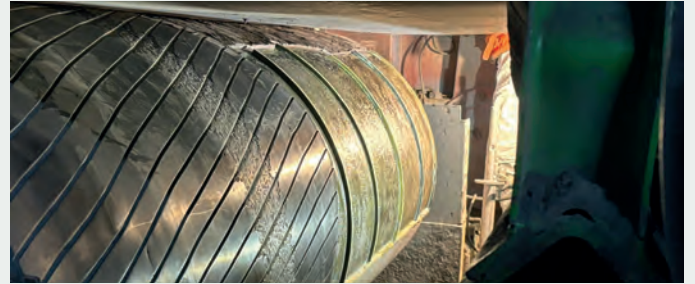
The drive pulley for the main feeder belt was shut down due to damage. The 45-inch by 105-inch (1143 mm x 2667 mm) drive pulley sustained considerable damage to three-quarters of its original lagging, resulting in substantial production losses at the mine.
